©Kawasaki Motors Corp 1974 Printed in USA

PROBLEM:

On early H1 and H2 models, there have been problems of gear engagement resulting from excessive play in the stationary gears on both the drive and output shafts.

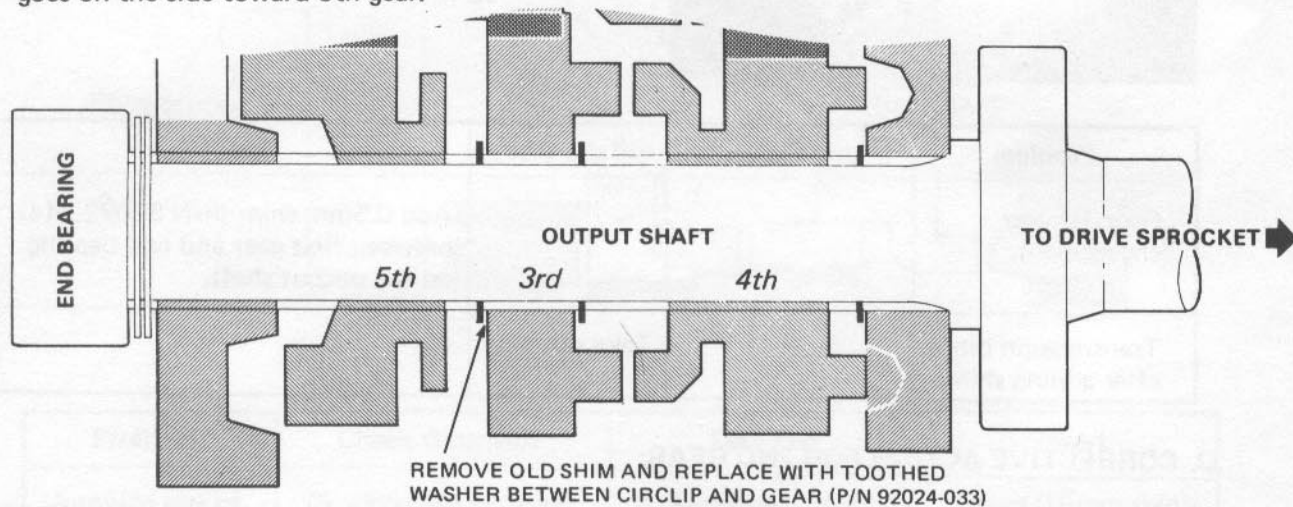
E. CORRECTIVE ACTION FOR 3RD GEAR:

The problem with third gear has primarily been the result of the shim between 3rd gear and the circlip spinning and wearing through the circlip. This causes third gear to move away from the slider and hop out of gear. The solution is to remove the standard shim (P/N 92022-076) and replace it with a toothed washer which cannot rotate (P/N 92024-033). The new washer goes on the side toward 5th gear.

Problem	Check Clearance	Take Out	Insert
Jumps out of 3rd gear.		Remove 1.0mm shim between 3rd gear and circlip on output shaft.	Insert 1.0mm toothed thrust washer (P/N 92024-033) between 3rd gear and circlip (5th gear side).
