*obsolete***PROBLEM:**

Some of the early S2 units may develop a rattling sound which seems to come from the right engine cover. The noise is most noticeable with the transmission in neutral, clutch hand lever released. When the hand lever is pulled, the rattling sound is eliminated. Usually, the noise is not present in a new unit, but develops within the first 500 miles of driving, if it occurs at all.

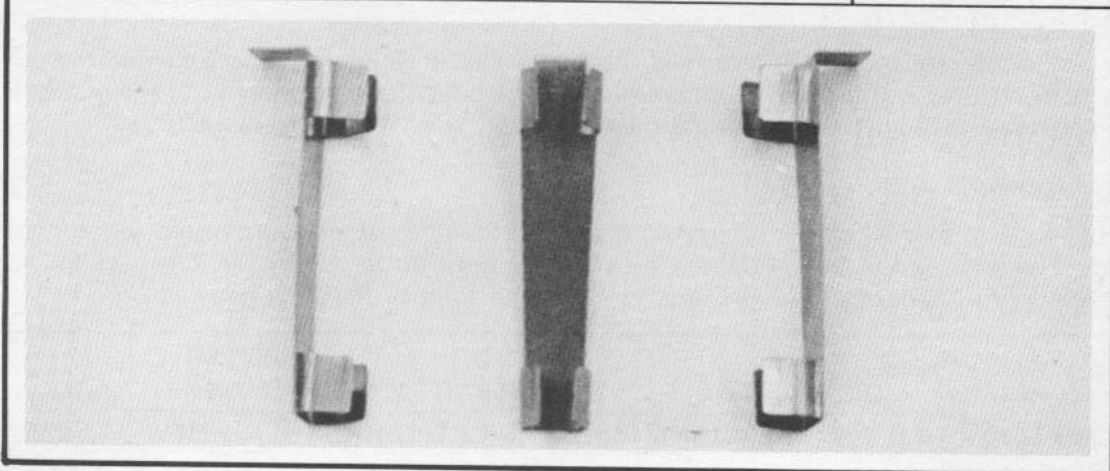
The rattling noise is evidence of excessive clearance between the clutch housing drive fingers and the driven tabs on the friction plates. Slight variations in the clutch housing RPM resulting from engine firing impulses cause the housing to speed up and slow down slightly, and the tabs of the friction plates, held together by the clutch spring, are struck on one side (load) and then the other side (coast) by the housing fingers. Standard clearance between the fingers and the tabs is 0.002-0.022" (0.05-0.555 mm). As the clearance exceeds 0.010" (0.25mm), however, clutch rattle becomes more evident.

SHIMS ON "COAST" SIDE ONLY

To take up the excessive clearance, Kawasaki has prepared clutch finger shims. Three shims are needed to repair one clutch.

To install the shims, drain the oil and take off the right engine cover. Remove the pressure plate bolts and springs, and then take off the pressure plate and pull the clutch plate "pack". Install the three shims as shown here, at 120° intervals, or 4 fingers apart. **IMPORTANT:** The shims must be installed on the "coast" side of the clutch housing finger. **NOTE:** Make sure the three shims are all the same thickness.

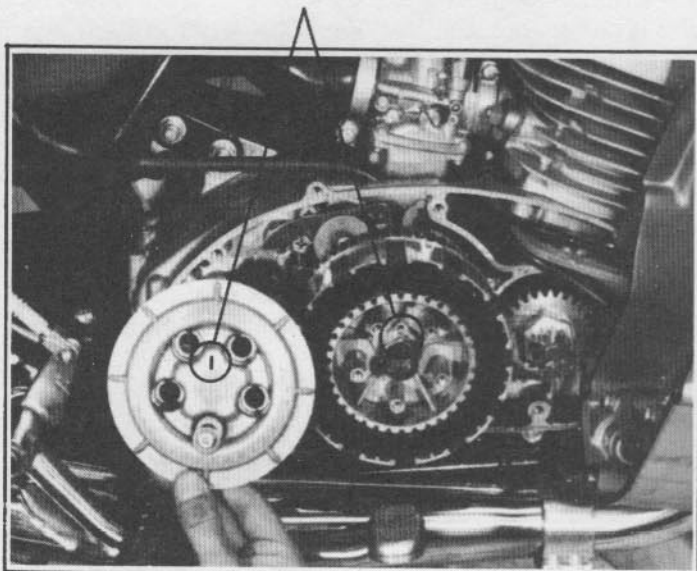
ALIGN MARK WITH LOCKWASHER HOLE

To assemble the clutch, start with the outer steel plate which is 0.075" (1.9mm) thick. Then install a friction plate, with spring ring. Alternate steel and friction plates until there are 5 steel and 6 friction plates. **NOTE:** The other 4 steel plates are 0.063" (1.6mm) thick. Make sure the pusher is in place, and then "time" the pressure plate as shown here.

Insert the clutch springs, and install the bolts with washers. Tighten the bolts to 4 lb.-ft.
