©Kawasaki Motors Corp 1974 Printed in USA

PROBLEMS:

H1/H2 transmission problems have often included poor third gear engagement. This may be caused by two possible problems including the play of the fixed gears on the shafts and the lack of positive action in the third gear shift fork.

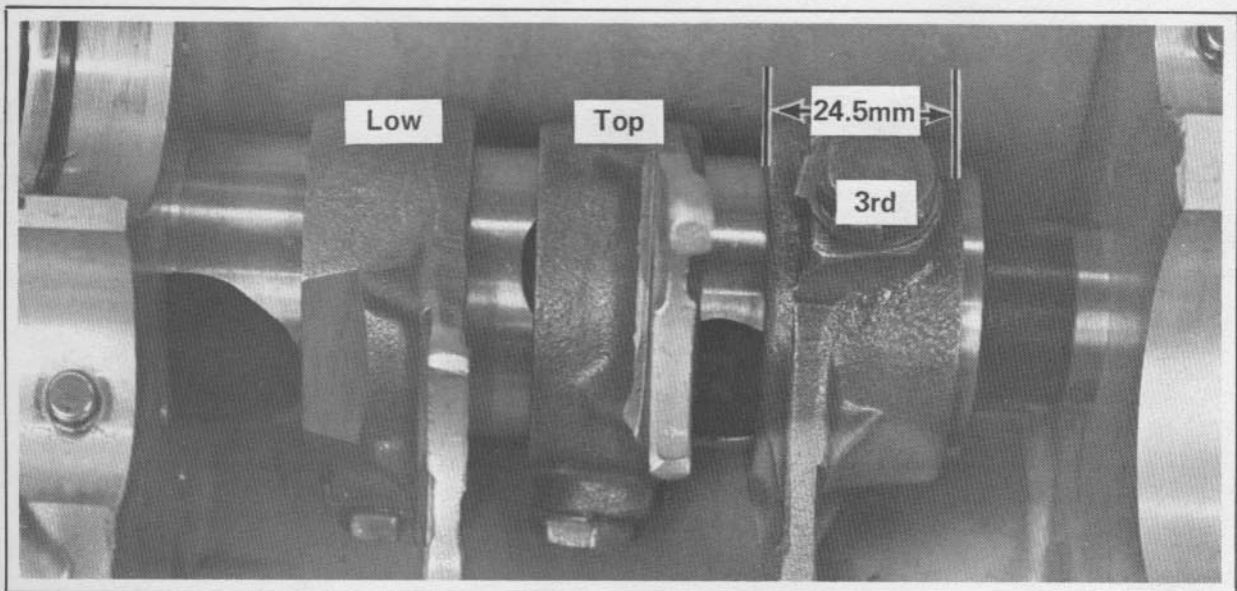
The new fork is easily recognized by its wide base.
