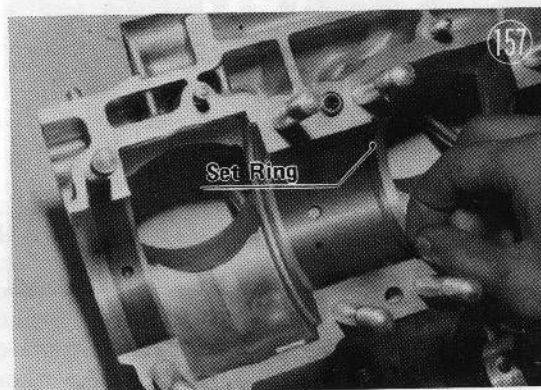
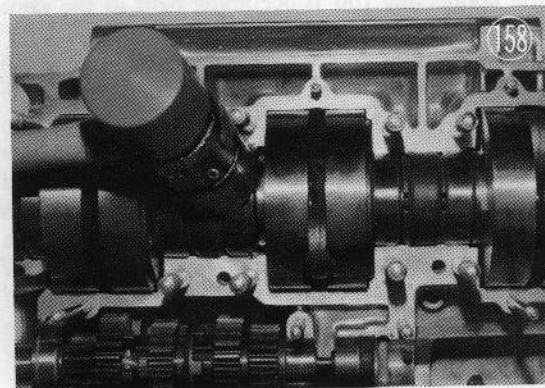
Place the bearing set rings in the upper crankcase and align the groove in each ball bearing to its ring. Seat the crankshaft by tapping each bearing lightly with a mallet.
